#### THE LUBRICATION OF HIGH SPEED CURVES

J Rastall Interfleet Technology Interfleet House Pride Parkway Derby DE24 8HX UK rastall.j@interfleet.co.uk

# DEMONSTRATION OF THE TRAINSAFE RESEARCH CLUSTER MECHANISM IN THE CONTEXT OF "ADHESION MANAGEMENT" WITHIN THE "SAFE INFRASTRUCTURE" RESEARCH CLUSTER

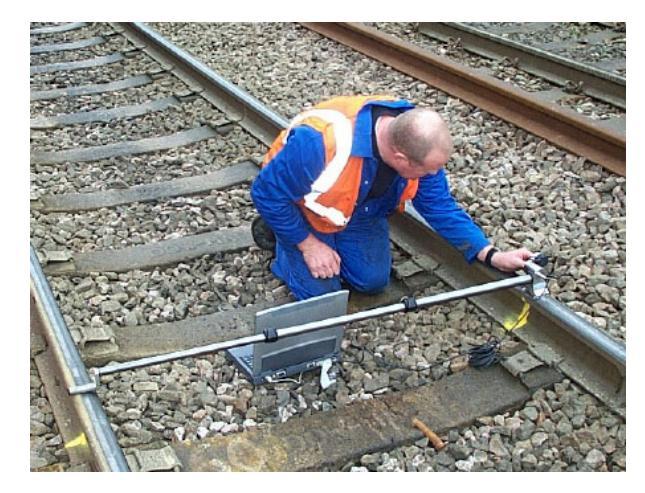
The Miniprof, shown in action, left, is used to measure the transverse profile of a rail to within 0.1mm or better. It is a small handheld device connected to a standard laptop computer which measures the rail head profile in-situ, together with the location and other identifying information. Subsequent measurements at the same location can calculate the amount of rail wear that has taken place.

The examinations of the curves concentrated on the high rails although profiles of both were routinely monitored. The measuring equipment used on site consisted of a Miniprof to check the rail transverse profiles and a Goop gauge to assess the amount of grease present on the rail around the curve to determine the effectiveness of the grease distribution at each site. Battery voltages were checked with a multimeter and visual assessments and photographs were taken to record the general conditions. The data collected was then collated for analysis.

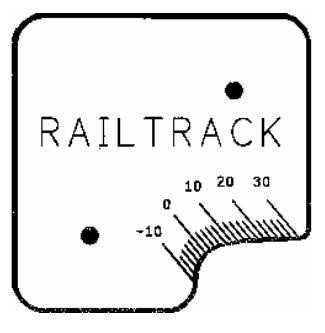
The Goop Gauge, shown left, is a simple template which is calibrated to assess the level of grease on the rail. The calibration is nominal and based on zero at the mid-point of the gauge corner radius. It has been surprisingly useful in quantifying the rate of propagation of the grease around the curves.

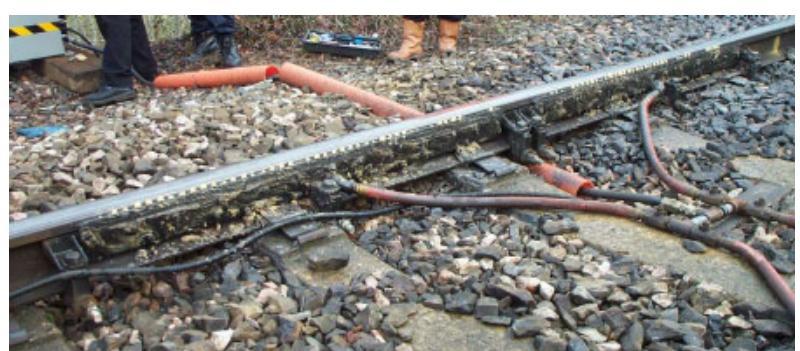
One of the lubricators used in this trial used blades 1200 mm long in pairs with a very small gap between. This resulted in almost complete coverage of a wheel circumference which resulted in an even coverage of grease around the following curves. Other lubricator designs

used four standard 400 mm long blades, spaced over four or five sleepers. This also resulted in a very even distribution of grease around the following curves.

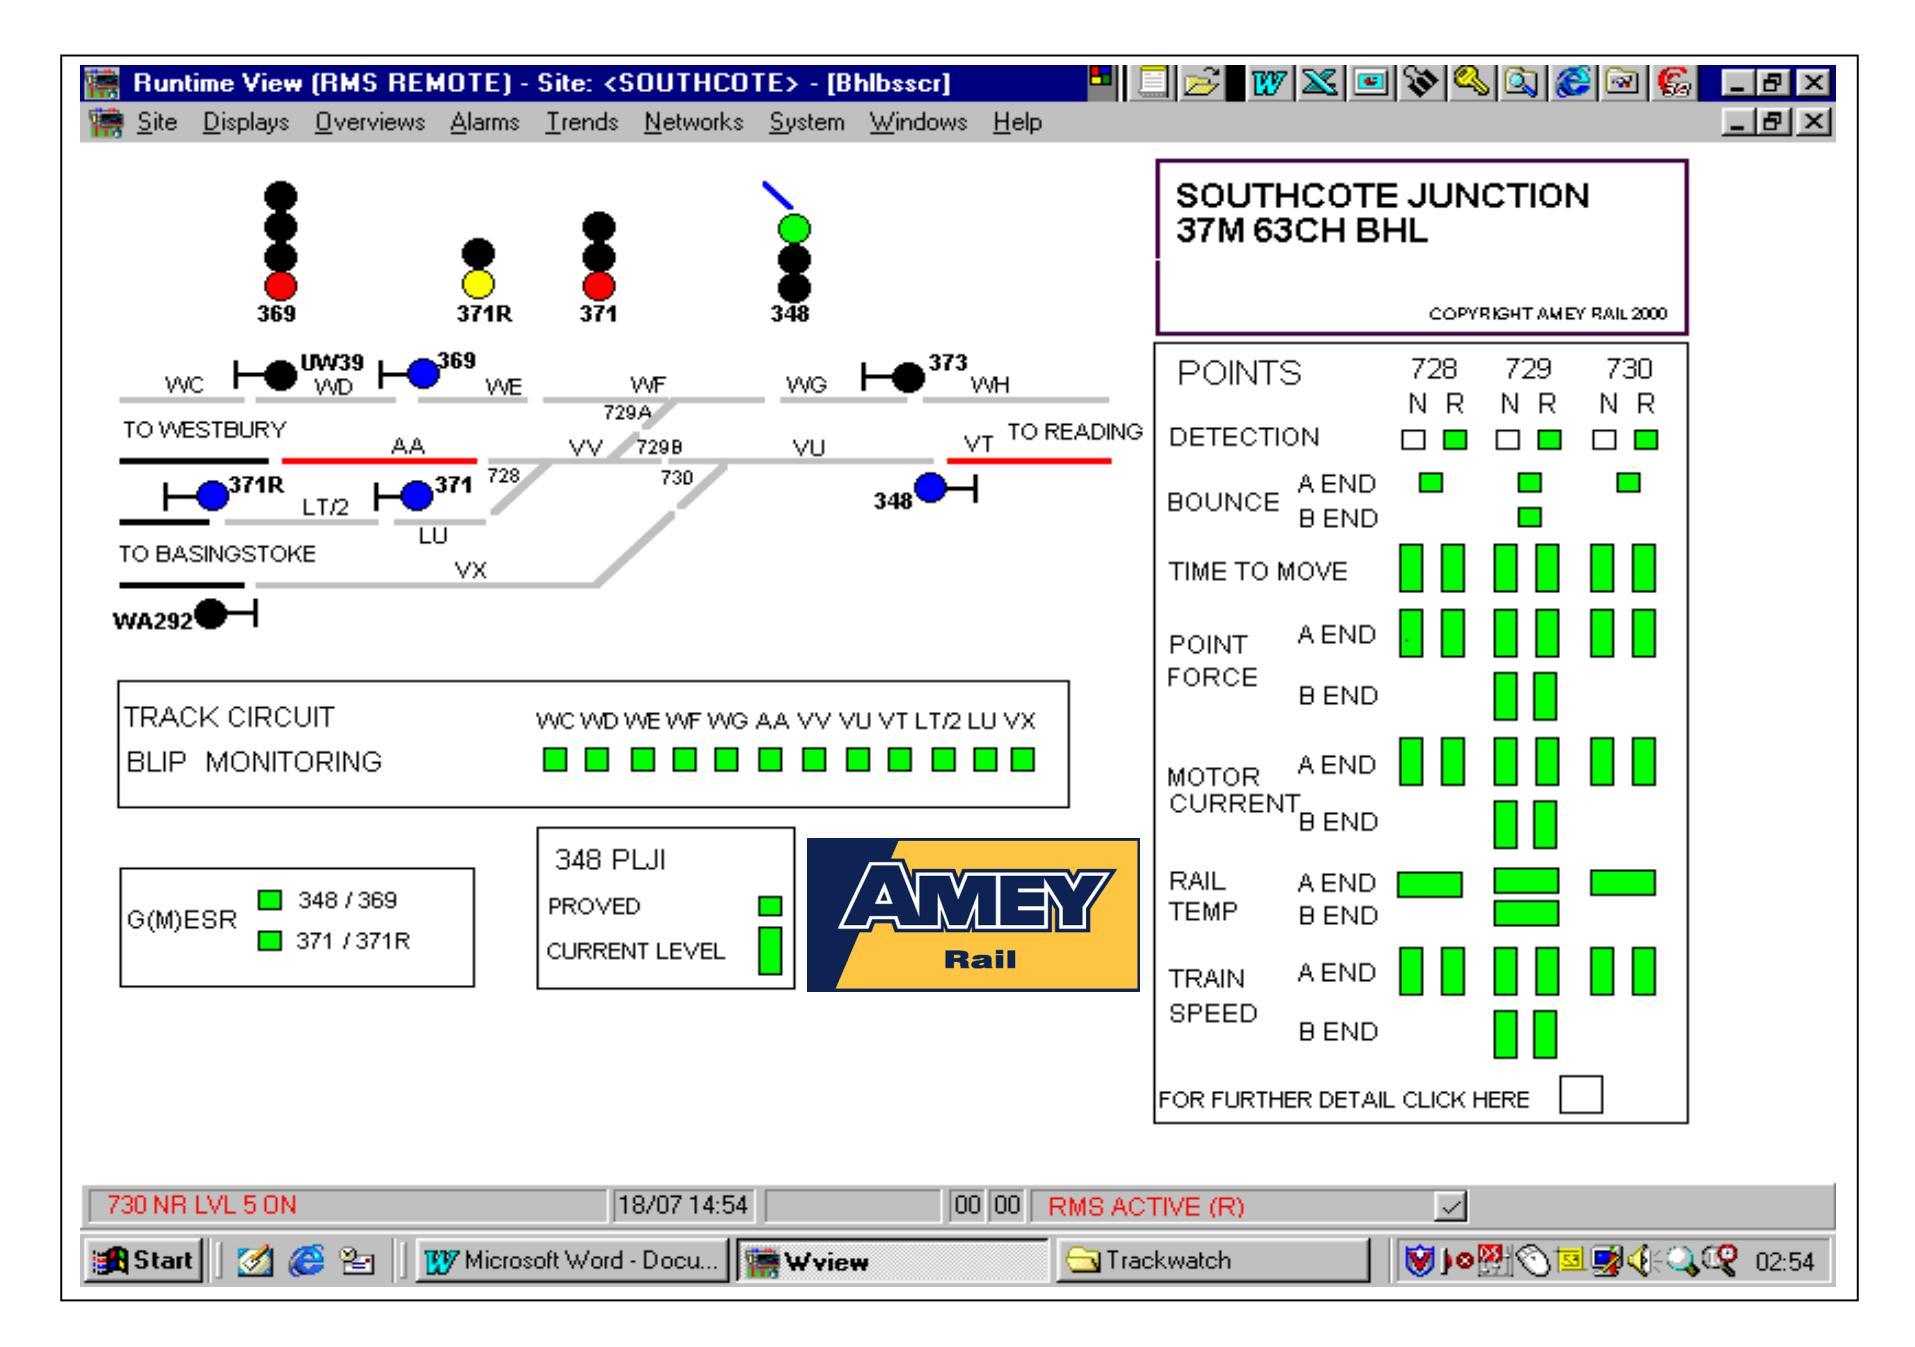
Figure 4: Maintainers Fault Screen developed jointly by Amey and cdsrail

This display is typical of those used in Great Western Zone to cover the area between Paddington and Reading. These screens use the data to provide management information that assists the maintainer to move from reactive faulting to proactive maintenance.

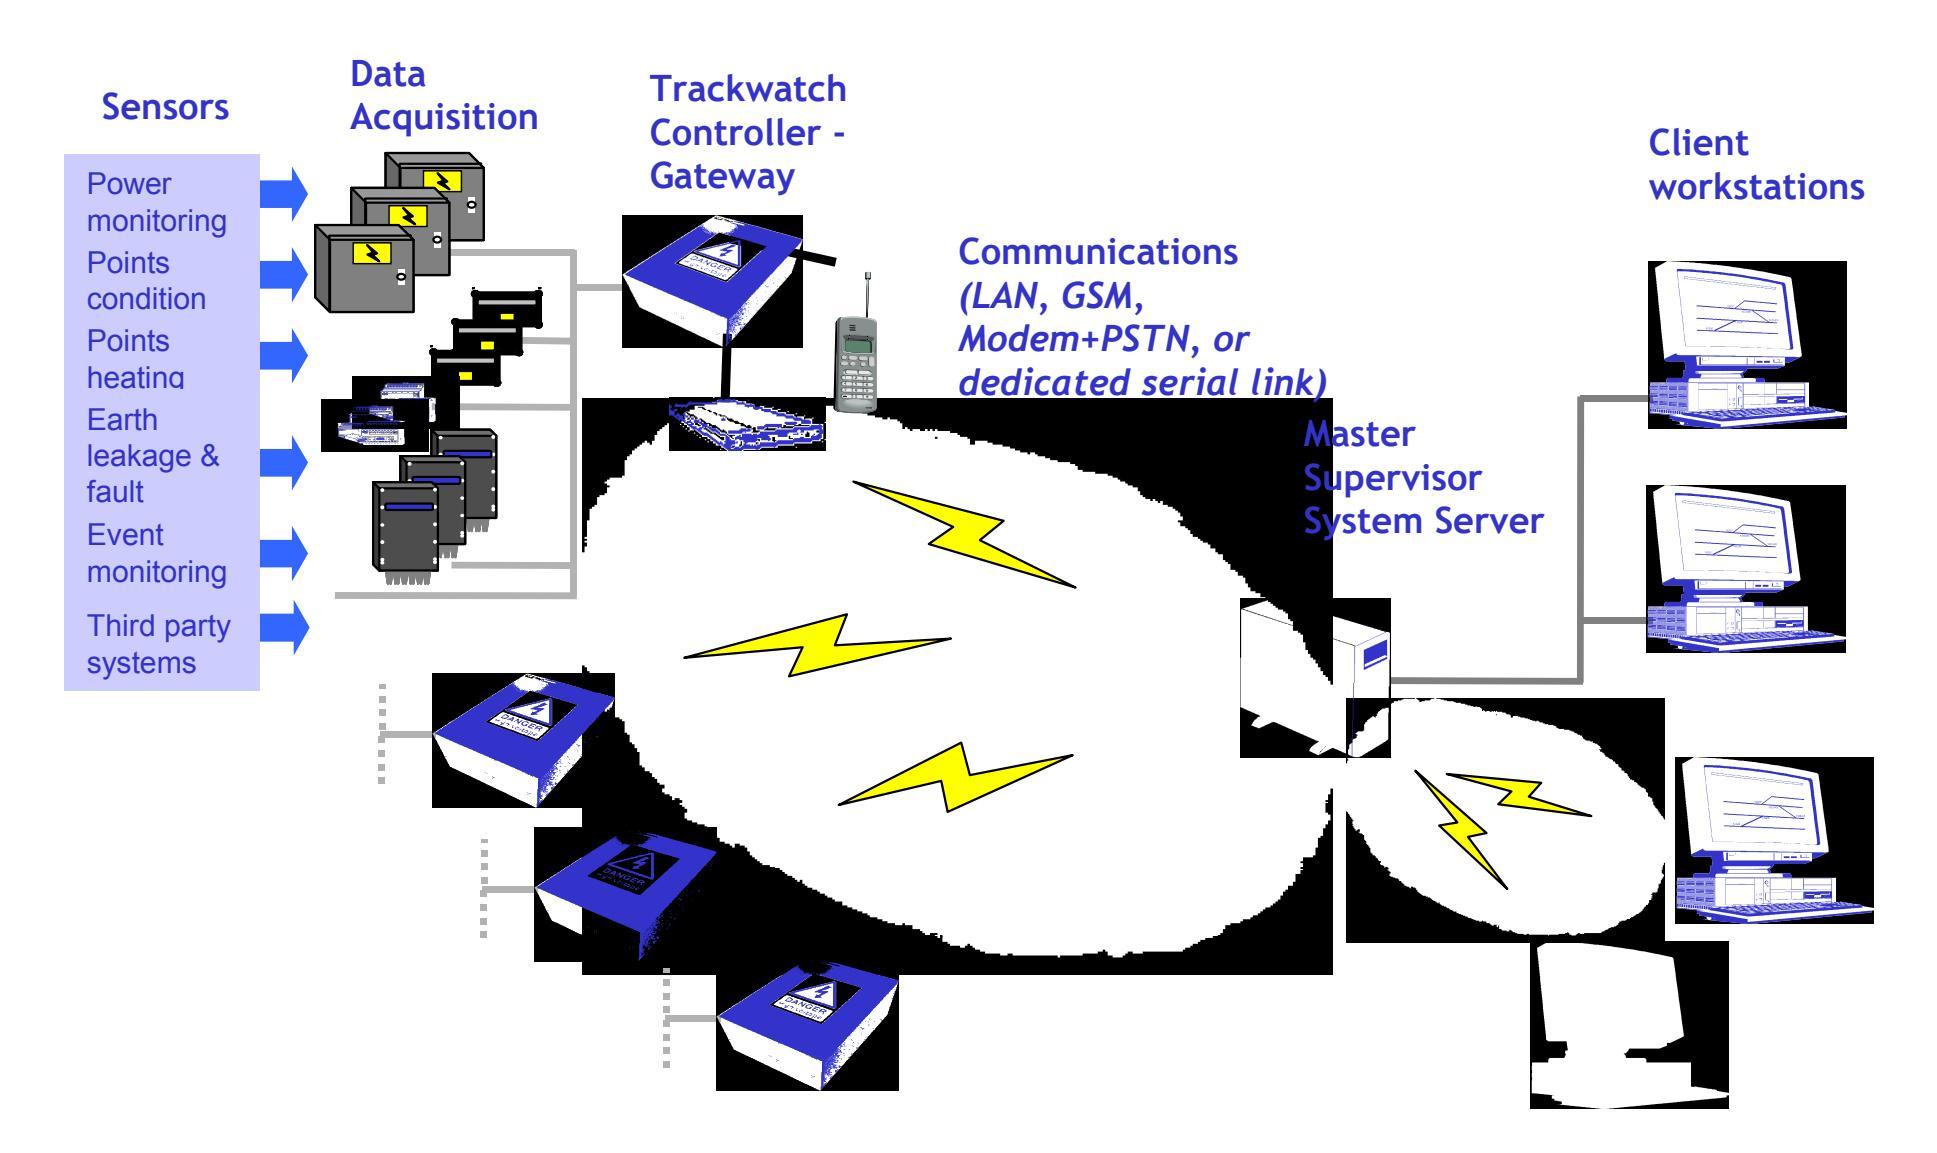
Figure 6: Master Supervisory System Architecture

Distributed sites can be routed through one or more Trackwatch controllers which act as gateways to the Master Supervisory System Server, a high specification machine incorporating an SQL database which provides standard connectivity. Such a system can provide multiple alarm options, such as SMS, pager and e-mail. Client machines provide live information on mimics from multiple sites.

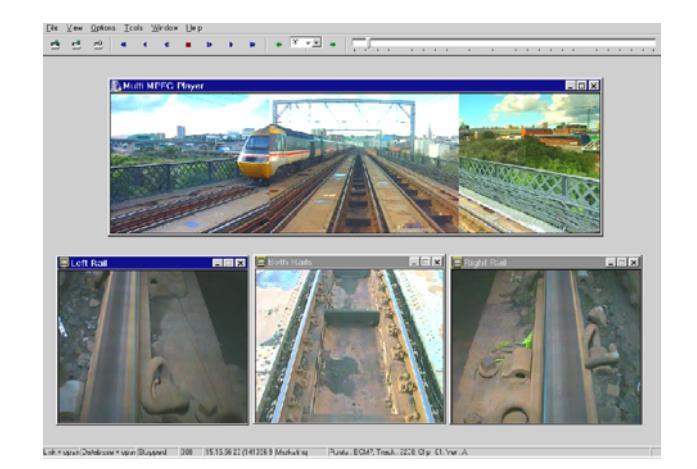
We see here an example of the different pictures that can be brought up with the OmniInspector software. You will note the extremely close detail of the fastening and how easy it is to see a missing clip from this.

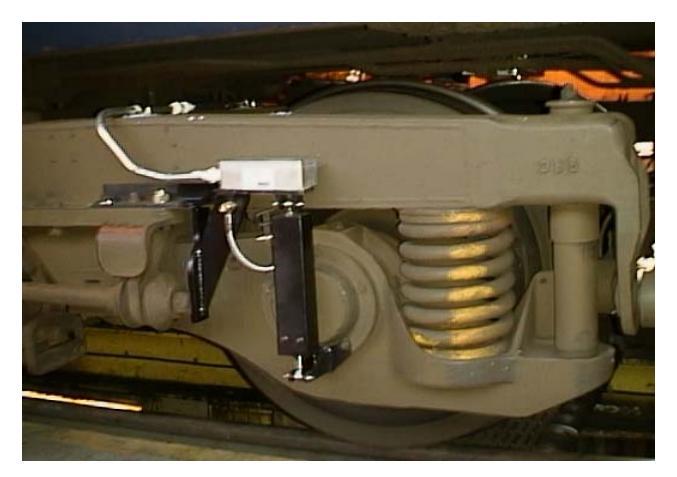
The train is also fitted with Trackmon by AEA, using sensors as we see here.

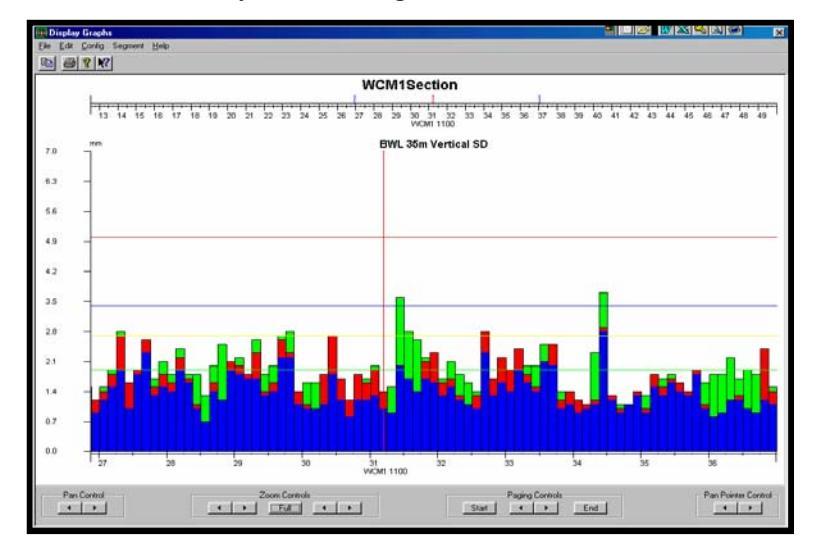
This is a typical Trackmon output, in this case a Manhattan Skyline showing the improvement and deterioration of track by 1/8 of a mile.

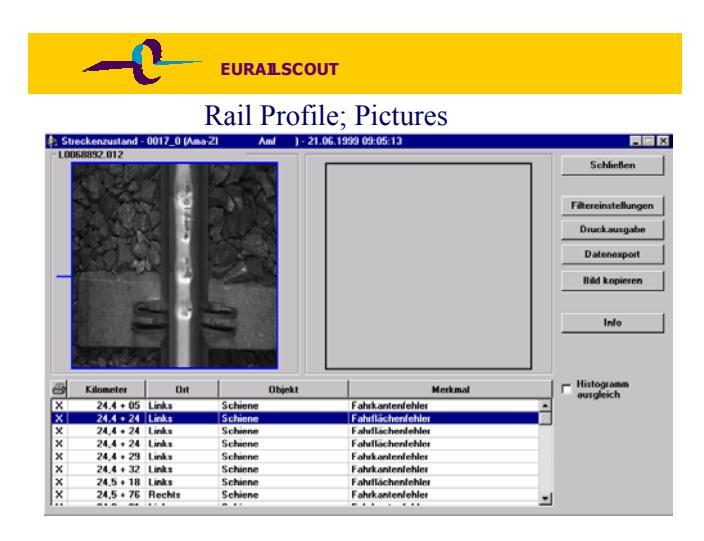
The system also shows defects in the rail head, which can include rail breaks.

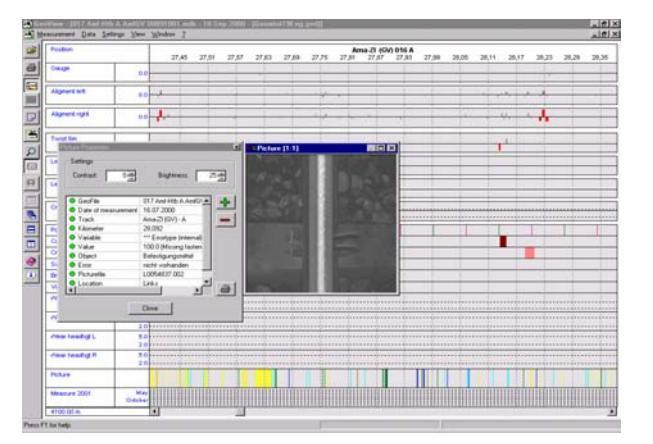
As I said earlier it is important this information is presented in a very accessible way and we see here the screen from the associated Geoview software with all the defects highlighted on one screen. When you click on a particular defect then either a text inscription or a picture is highlighted as we see here for a missing fastening,

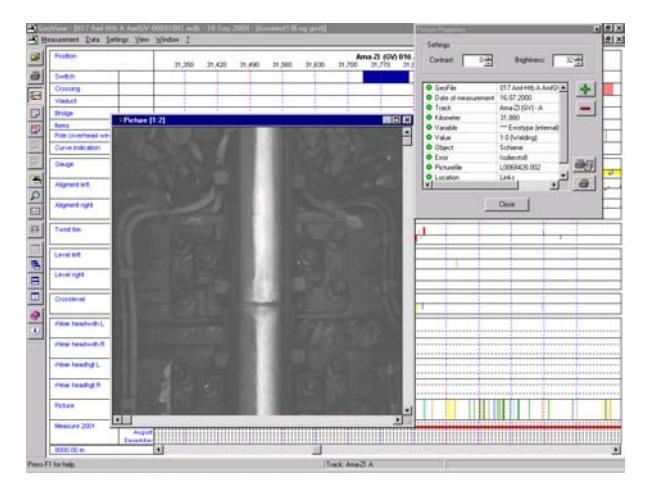
Similarly we see here a fish plate shown – the joint is identified by the rail defect software. Thus not only is it possible to look at pictures of each defect or technical information, but Geoview can also summarise the output, bringing parameters together in a similar way to a track recording run.

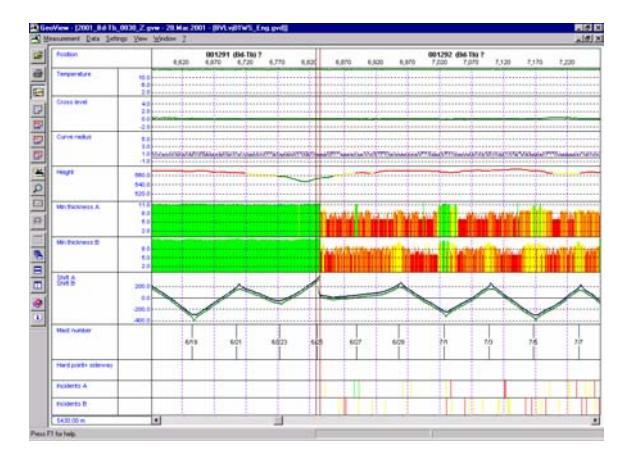
Finally Geoview sends out similar recording and analysis and puts it forward before the Overhead Line and you can see here how it shows staggers and various other overhead line parameters in the screen.

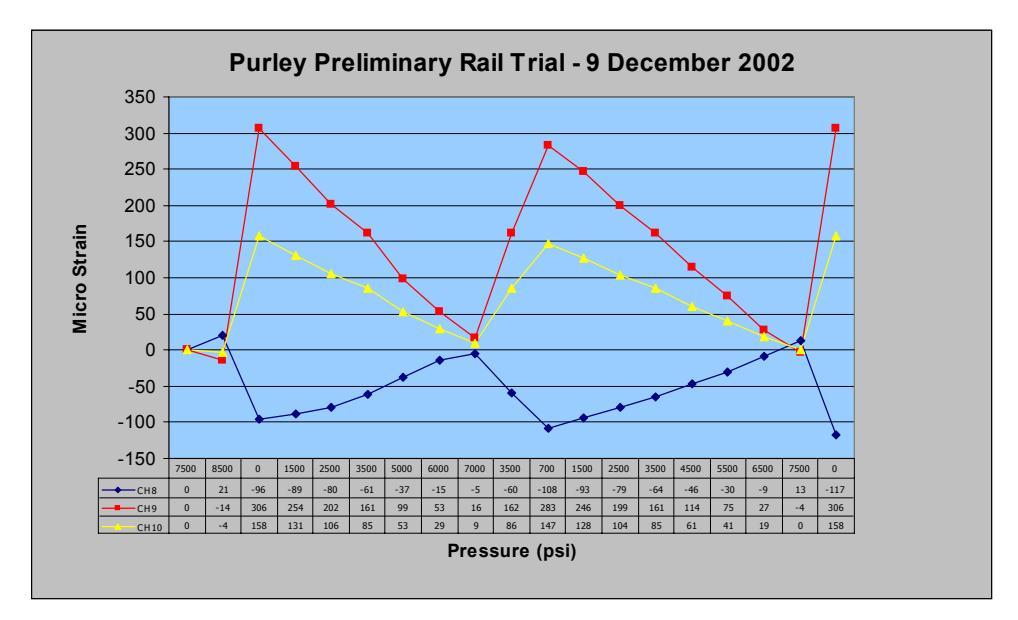
Figure 1: Purley Preliminary Rail Trial Strain Results

Strain measurements were taken by stepping the tensioner pressure incrementally to a maximum of 7,500 psi and back down to zero. *Figure 1* below shows the results obtained where Channel 8 is the transverse rail flange strain, Channel 9 the longitudinal rail flange strain and Channel 10 the shear rail flange strain.

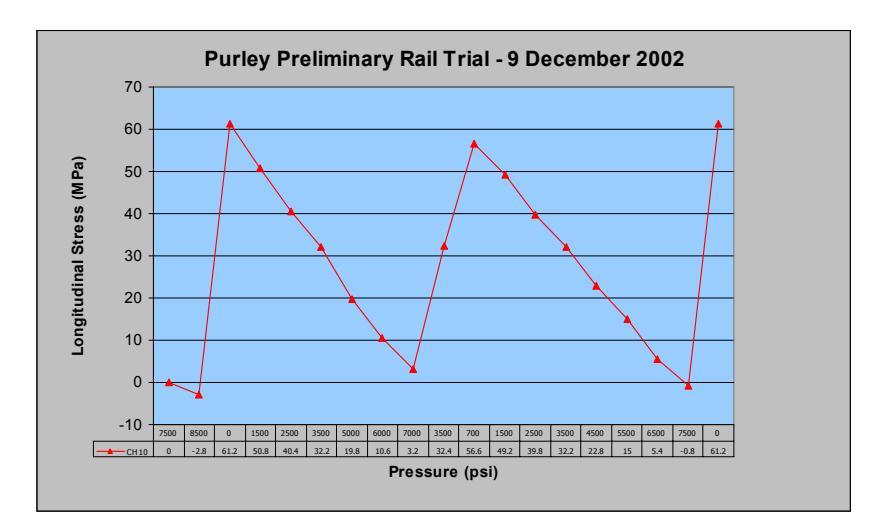
Figure 2: Purley Preliminary Rail Trial Longitudinal Rail Stress

*Figure 2* below shows the results of the longitudinal strain in terms of longitudinal stress. The range shown is approximately 60MPa, which is well within the capability of SMT.

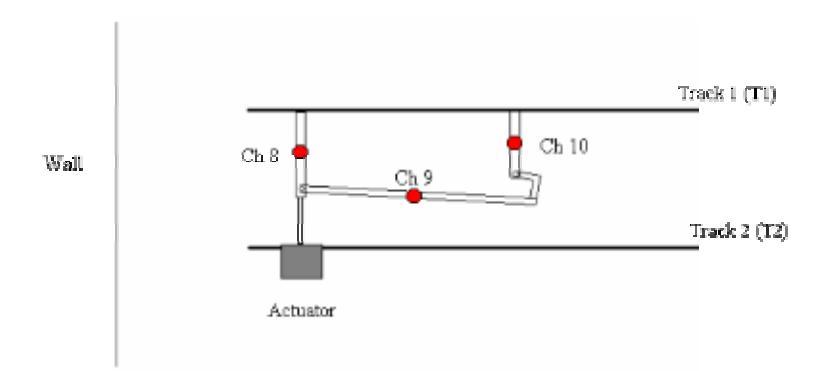
Figure 3: Clapham Jct. Points Preliminary Trial Set-up

Preliminary points trials were carried out at a training centre near Clapham Junction where a set of hydraulically operated points was made available for strain measurements. This time it was decided to measure strain on three separate components of the points switching mechanism. There were the  $1\frac{1}{4}$ " connection rod at the drive end (Channel 8), the channel section connecting the drive and back end (Channel 9) and the  $1\frac{1}{4}$ " connection rod at the back end (Channel 10). These locations are shown in *Figure 3* below:

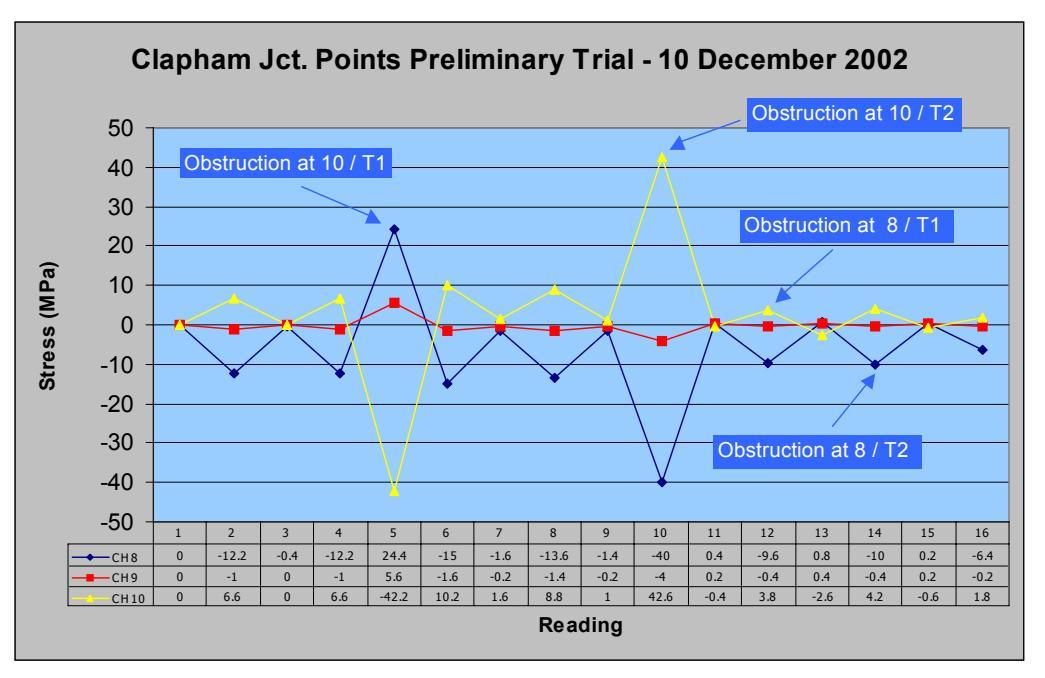
Figure 4: Clapham Jct. Points Preliminary Trial Stress Results

The three gauges were again connected to the Vishay Measurements Group P-3500 Strain Indicator and SB-10 Switch and Balance Unit [8]. The points were switched twice normally and then were switched with obstructions placed at back end on track T1, the back end on Track T2, power end track T1 and power end track T2. *Figure 4* shows the stress results from the three locations.

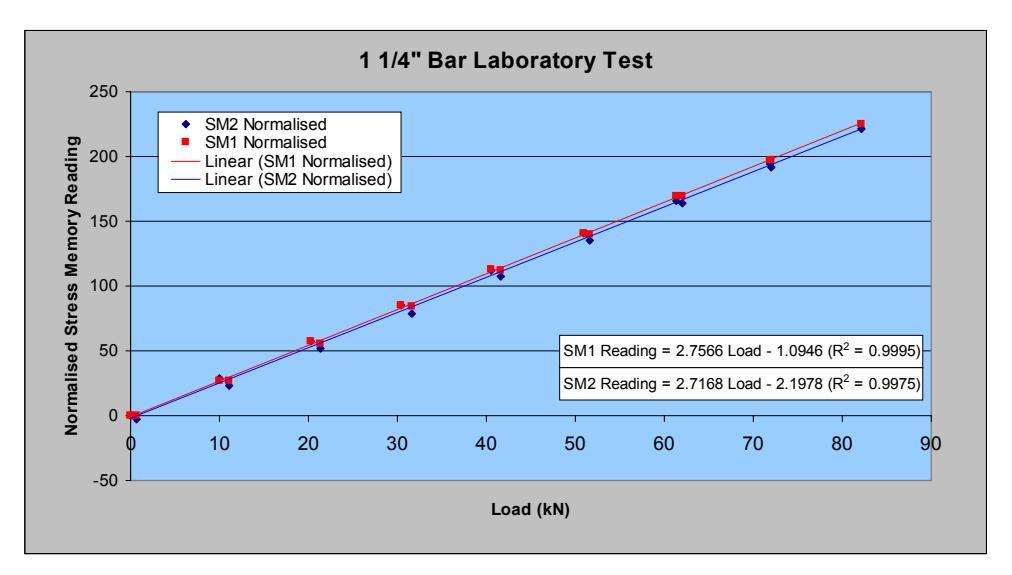
Figure 5: Normalised SM Readings plotted against Load

*Figure 5* below shows the results from two different units on the same bar in the laboratory normalised to their first reading at zero stress.

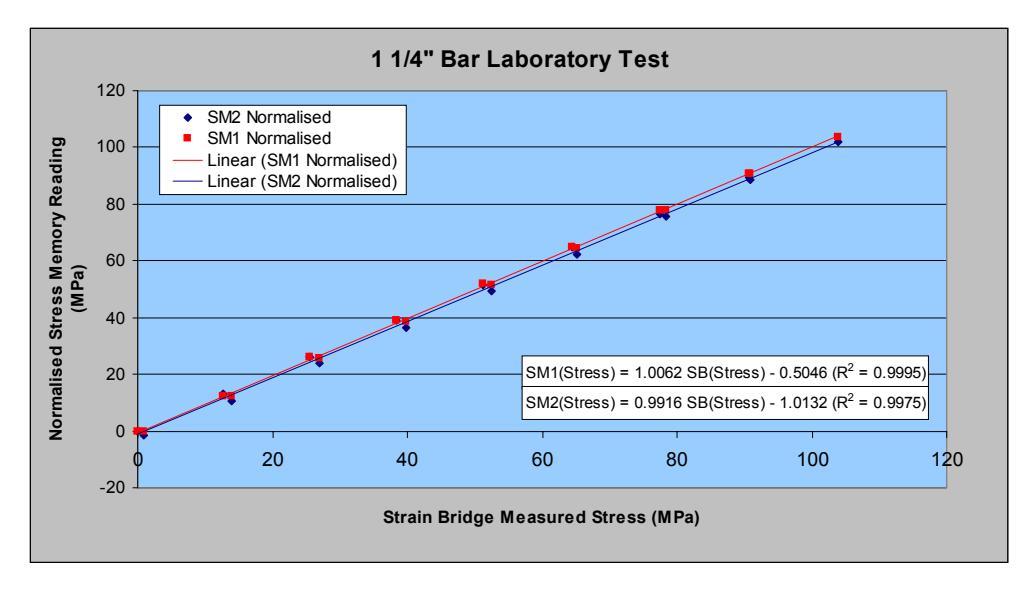
Figure 6: Normalised SM (Stress) Readings plotted against Strain Bridge Measurements

Straight-line fits to each set of data show very similar behaviour and very low level of scatter. Relating both of these to the Stress in each bar by simply dividing the load by the cross-sectional area allows the data to be presented in terms of stress as shown and compared with Strain Bridge measurements in *Figure* 6 below. The SM readings can be seen to be sensitive in the 0 - 40 MPa range as measured during the Clapham preliminary points trial.

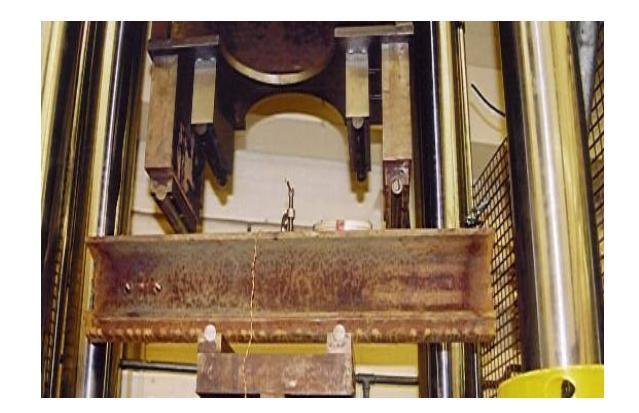
Figure 7: Rail Section in 1000kN Test Machine under Four Point Bending

Again in preparation for the field trials of the SM equipment, a length of rail was set-up under four-point bending in a 1000kN (100 Tonne) servo hydraulic testing machine (*Figure 7*). The specimen was oriented upside down in the set-up shown so to give tension in the lower flange as would occur under rolling stock loading.

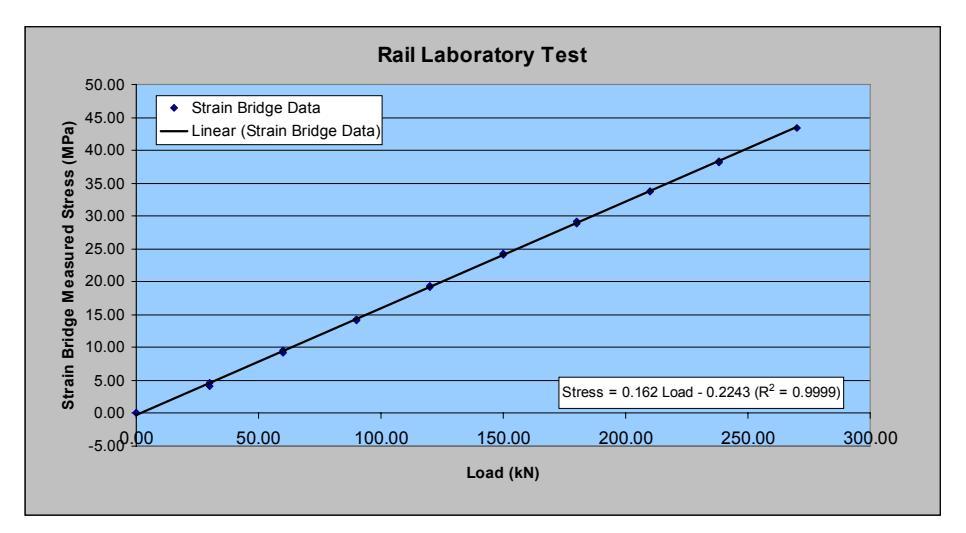
Figure 8: Strain Bridge Stress Measurements plotted against Load

As with the rod, the rail was strain gauged and connected to the Vishay Measurements Group P-3500 Strain Indicator and SB-10 Switch and Balance Unit [8] and loaded incrementally up and down. The results of this "calibration" are shown in *Figure 8* below.

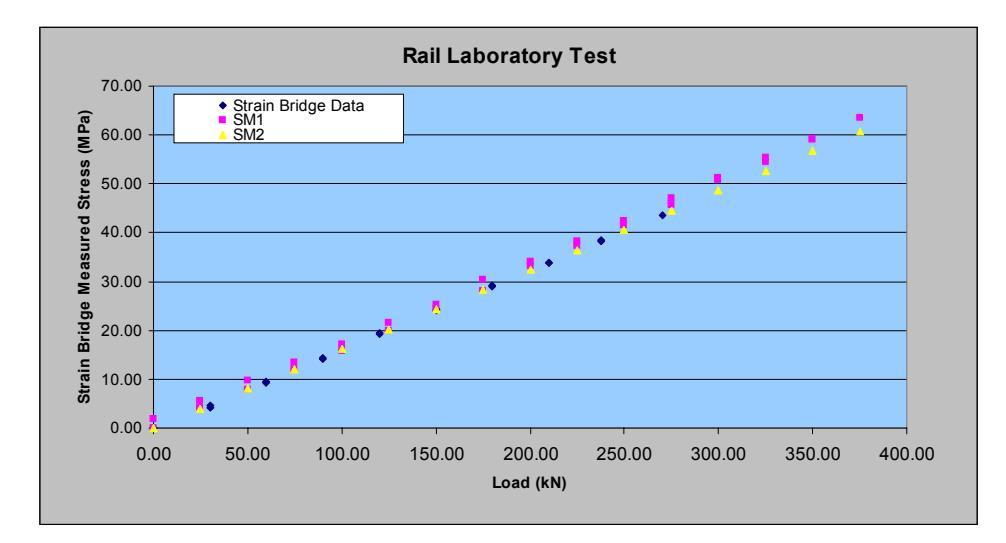
Figure 9: SM and Strain Bridge Stress Measurements plotted against Load

Finally, to compare stress measurements from both SM units and the strain bridge data, all data was plotted together and is shown in *Figure 9*. Good correlation of the quality expected from laboratory equipment is again apparent.

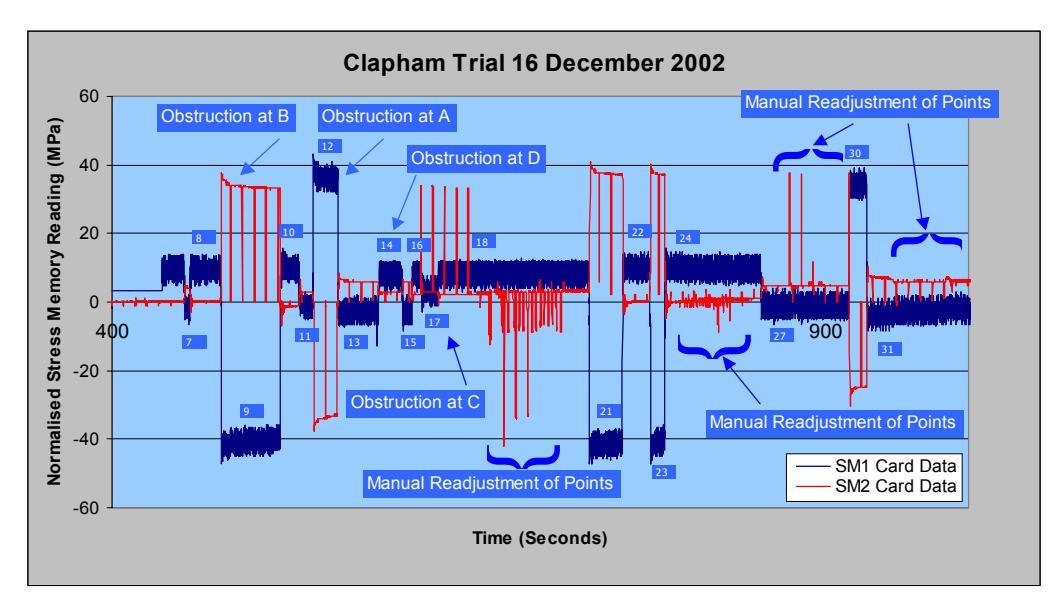
Figure 10: Clapham Trial Results – 16 December 2002

7	Switched to T2	14	Switched to T1, Obstruction at D	23	Switched to T2
8	Switched to T1	15	Switched to T2	24	Switched to T1
9	Switched to T2, Obstruction at B	16	Switched to T1	27	Switched to T2 – adjusted back
10	Switched to T1	17	Switched to T2, Obstruction at C	30	Switched to T1 – adjusted other way
11	Switched to T2	18	Switched to T1	31	Switched to T2
12	Switched to T1, Obstruction at A	21	Switched to T2 – points adjusted		
13	Switched to T2	22	Switched to T1

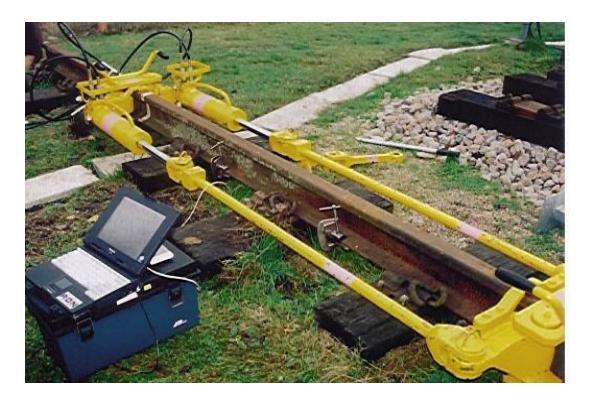
Figure 11: SM set-up on Rail at Purley

SM Units were fixed at two points along the test rail at Purley as shown in *Figure 11* below.

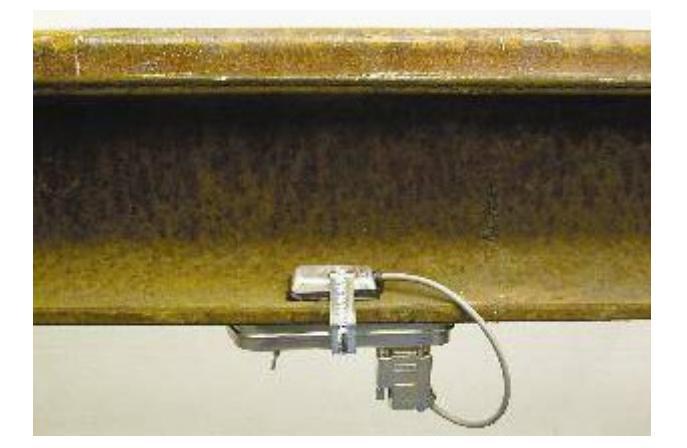
Figure 12 Stress Memory Unit connected to rail base

*Figure 12* below shows a close up view of the SM unit with a sub unit clamped to the upper surface of the bottom flange and connected to the main SM unit.

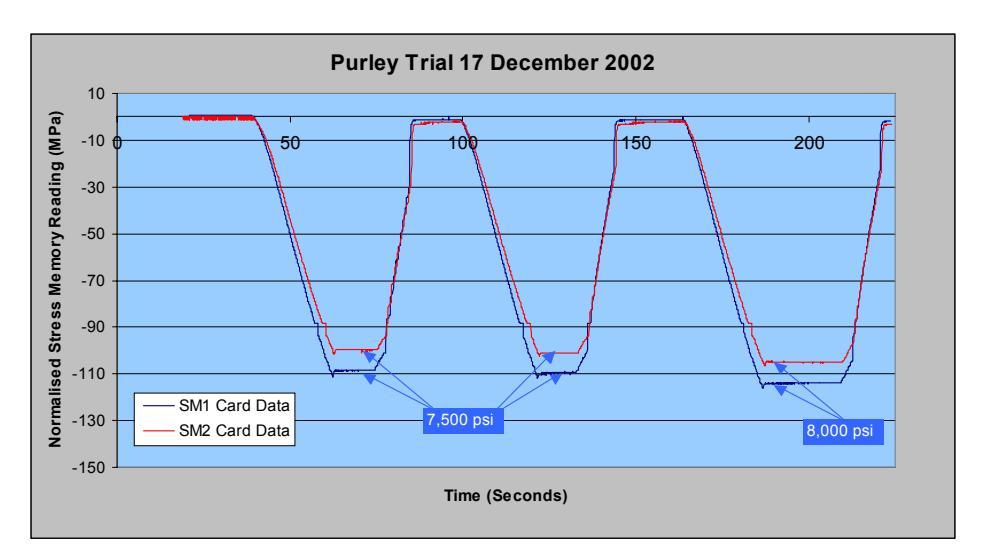
Figure 13: Sample SM results from the Rail Trial at Purley – 17 December 2002

This time there was no need to incrementally step the load as the SM units recorded continuously. Results from both units are shown in Figure 13 below.

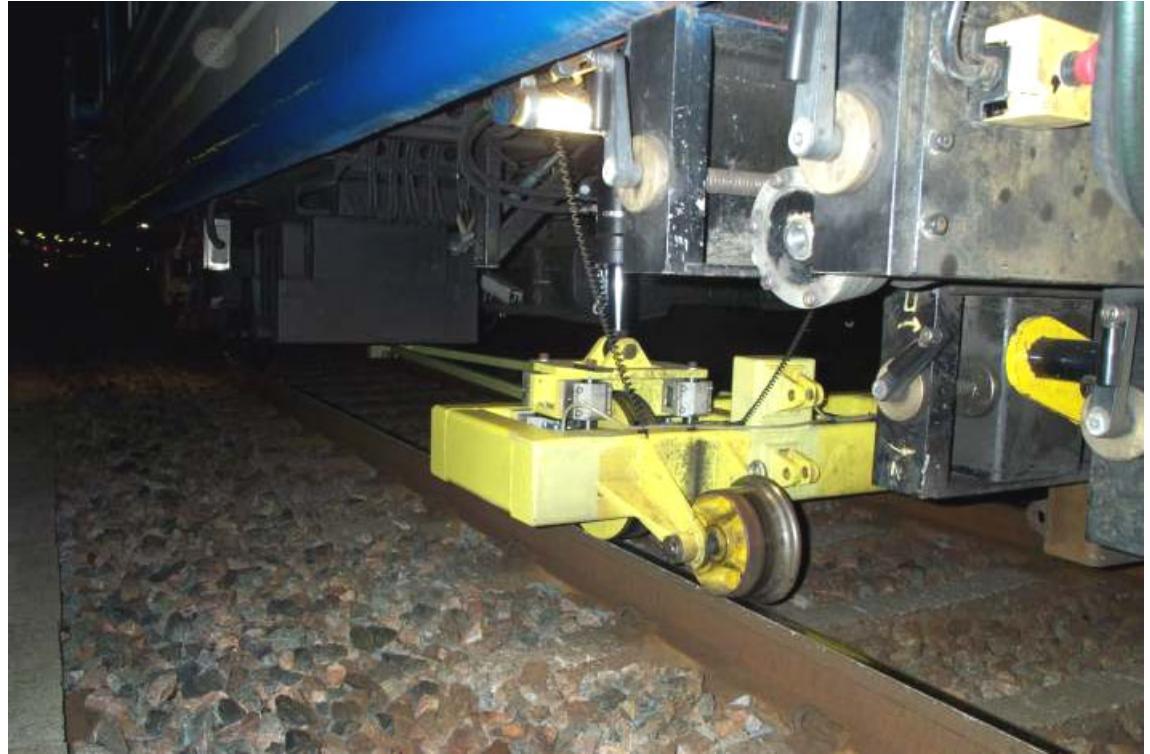
Figure 7: TVL with trolley

Continuous track stiffness is measured with a trolley beneath the Swedish Track Loading Vehicle as shown in figure 7. The measurement principle is based on a dynamic load excitation through a flange free measurement wheel. The force and the acceleration is measured and processed to obtain the stiffness, see figure 8. The applied load is 30 kN static load and 10 kN dynamic load on each wheel. The applied load is restricted in the present prototype version of TLV. Higher load will be applied in a future version. The measurement principle is described in detail in (Berggren et al 2002).
